**PRELIMINARY ASSESSMENT/  
VISUAL SITE INSPECTION**

**RELIABLE METAL FINISHING  
ZION, ILLINOIS  
ILD 122 328 677**

**FINAL REPORT**

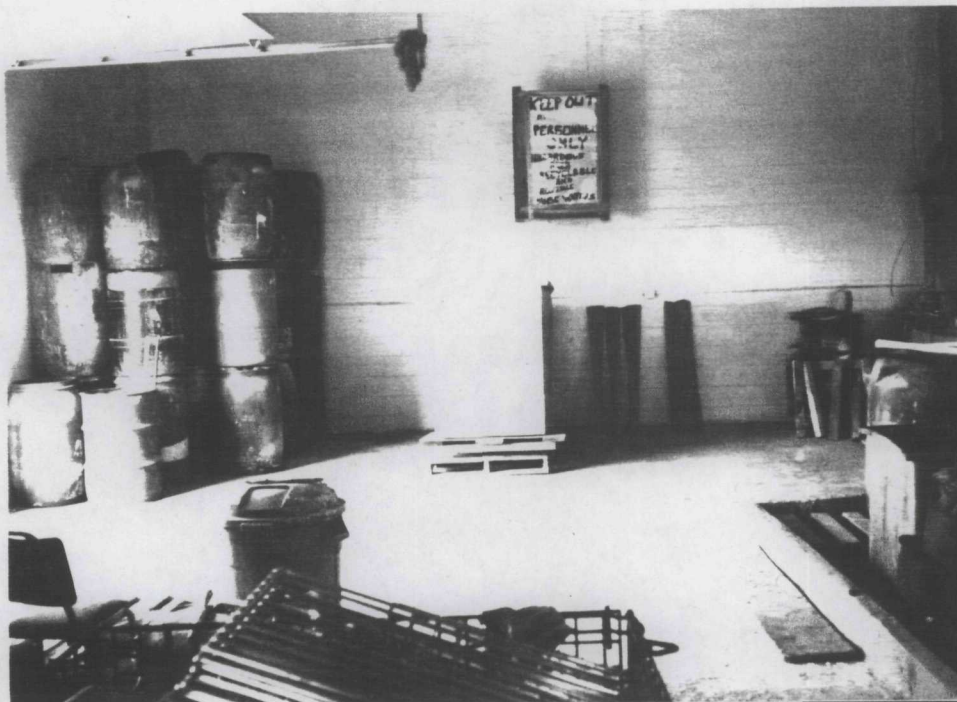
Photograph No. 1 (No. 11 in field notes)

**Observations:** During the VSI, PRC observed no waste being stored in this unit. Empty drums were stacked in the northwest corner of the unit, and an empty tank was also present (see Photograph No. 1).

**Recommendations:**              PRC recommends that the facility close this unit in accordance with an IEPA-approved closure plan. A revised closure plan is currently being prepared for the facility by DAI.

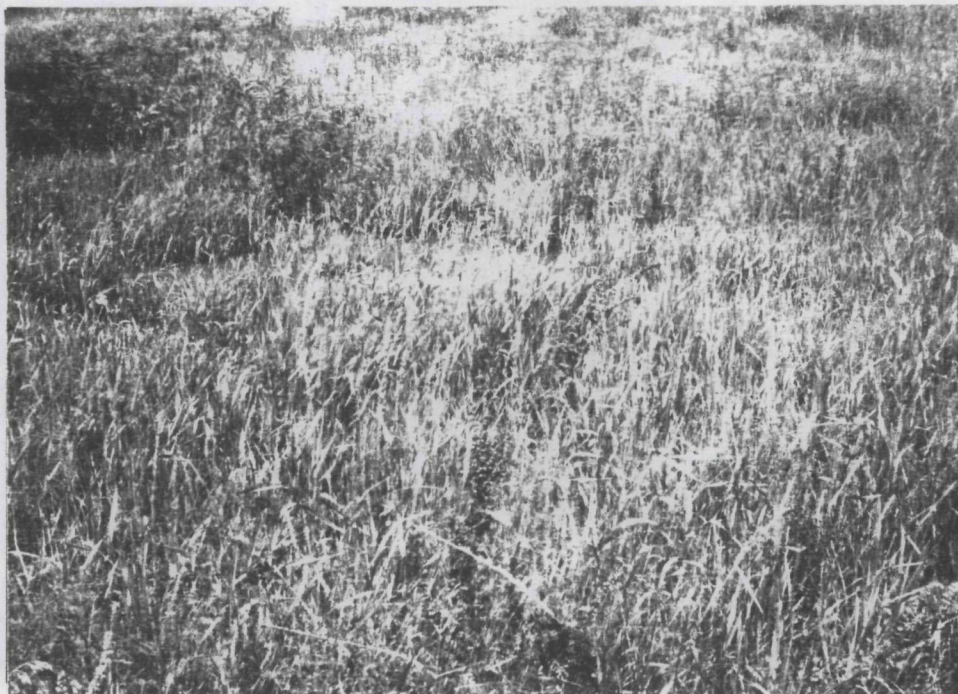
Photograph No. 2 (No. 15 in field notes)

**History of Documented Releases:** During an April 15, 1988, IEPA inspection, the liquid waste in this unit was found to have a pH of 1 and a chromium content of 124 mg/L. The other sample contained chromium at 0.023 mg/L (IEPA 1989a). These results indicated that the liquid waste was hazardous. However, the two soil samples collected on June 7, 1988, by IEPA were found to be nonhazardous.

**Observations:** PRC noted a pool of standing liquid that appeared to be rain water in this area during the VSI. The area surrounding the water was fully vegetated, and no stains were noted on soil in the area (see Photograph No. 2).

Recommendations: PRC recommends that the facility close this unit in accordance with an IEPA-approved closure plan. A revised closure plan is currently being prepared for the facility by DAI.

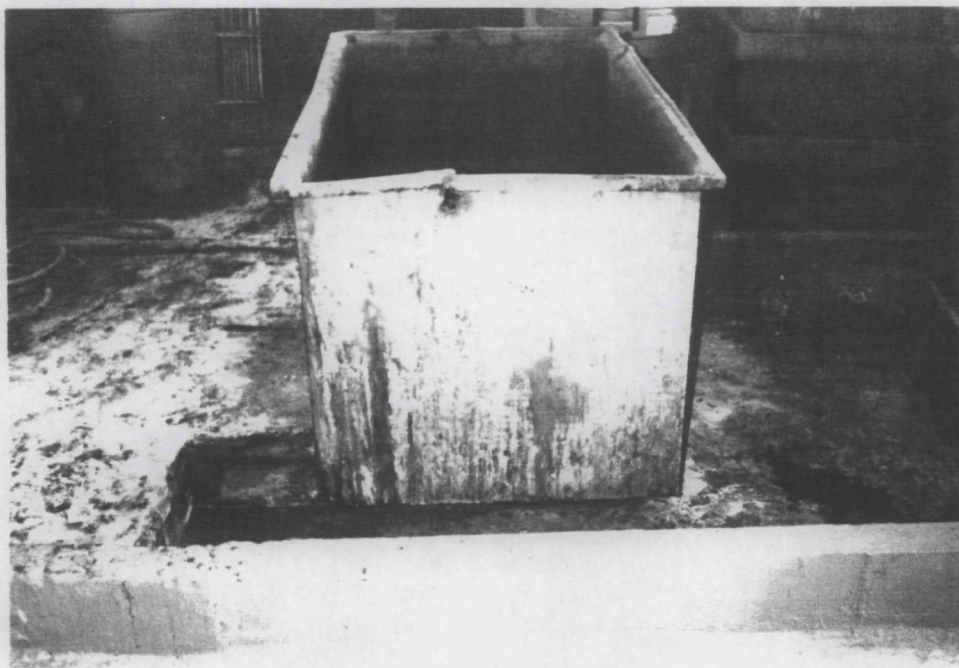
Photograph No. 3 (No. 1 in field notes)

Two soil samples were collected from under the unit on February 8, 1990. The soil samples contained chromium at levels of 47 and 90 ppm (DAI 1990a). On the same date, groundwater samples were collected and found to contain less than 0.05 mg/L chromium (DAI 1990b).

During the time of the VSI, a rinse tank was covering the area where this unit is located; therefore, the integrity of the existing concrete at this unit could not be observed (see Photographs No. 3 and 4).

Description: Tank formerly located in the Former Pit (SWMU 3); tank now used as a rinse tank for precleaning

Recommendations: PRC recommends that the facility close this unit in accordance with an IEPA-approved closure plan. A revised closure plan is currently being prepared for the facility by DAI. PRC also recommends that RCRA groundwater monitoring wells be installed downgradient of the entire facility and that groundwater sampling be conducted as requested by IEPA.

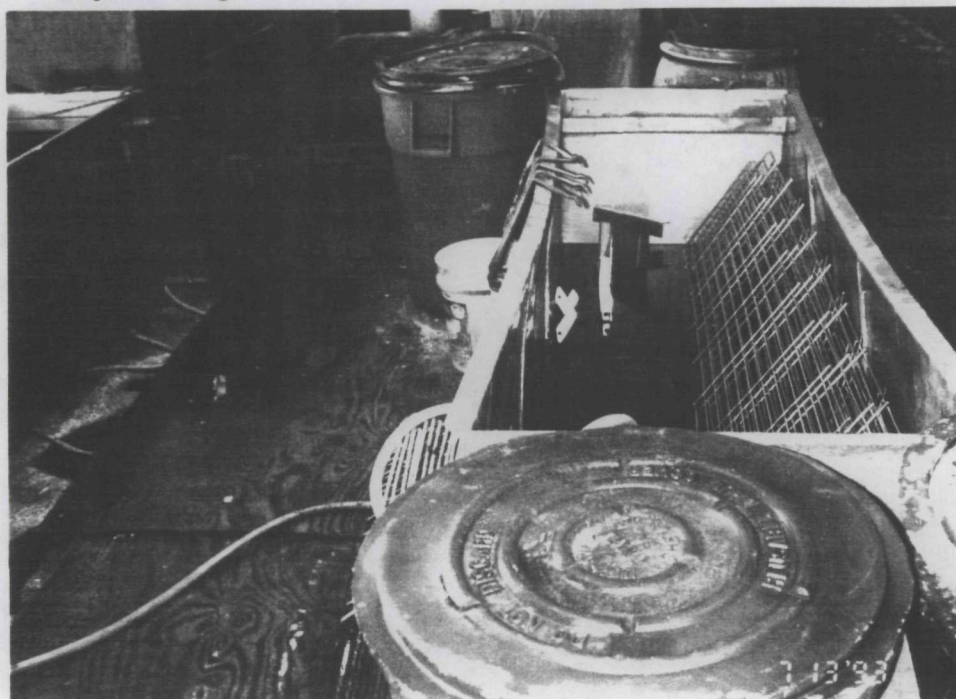
Photograph No. 4 (No. 8 in field notes)

Description: Former Pit and Process Waste SAA; rinse tank and wooden pallets now cover the Former Pit area; barrels in the surrounding SAA are empty

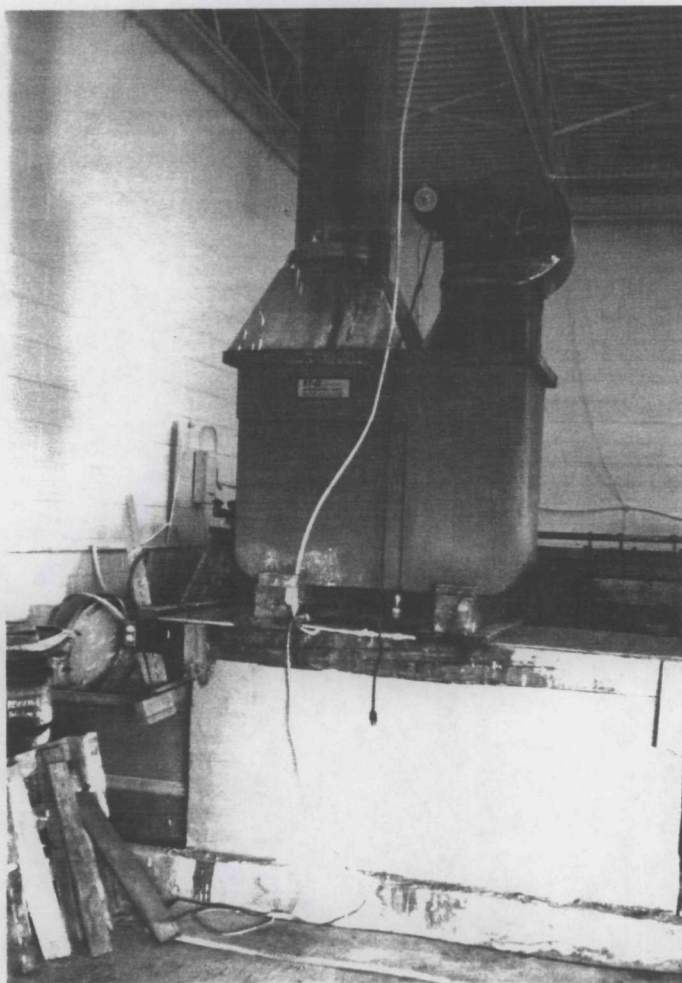
Photograph No. 5 (No. 9 in field notes)

**Observations:** PRC observed green stains on the walls of the unit. No spent rinse water was being evaporated at the time of the VSI (see Photograph No. 5).

Recommendations: PRC recommends that the facility apply for an air permit as requested by IEPA.

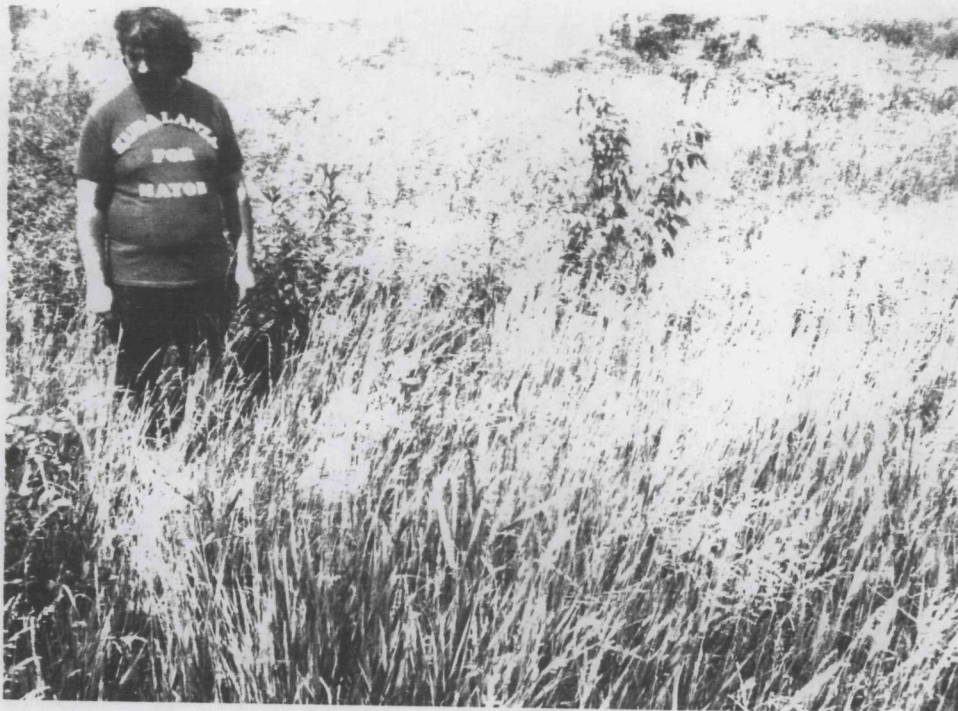
Photograph No. 6 (No. 13 in field notes)

**Observations:** PRC did not observe any stressed vegetation or soil stains at this unit (see Photograph No. 6).

Groundwater and on-site soils: Moderate. This unit was located directly on soil. It is likely that leachable hazardous constituents migrated to on-site soils and possibly groundwater. Also, it is unknown if all of the contamination was remediated when the pile was removed.

Recommendations: PRC recommends that the facility close this unit in accordance with an IEPA-approved closure plan. A revised closure plan is currently being prepared for the facility by DAI.

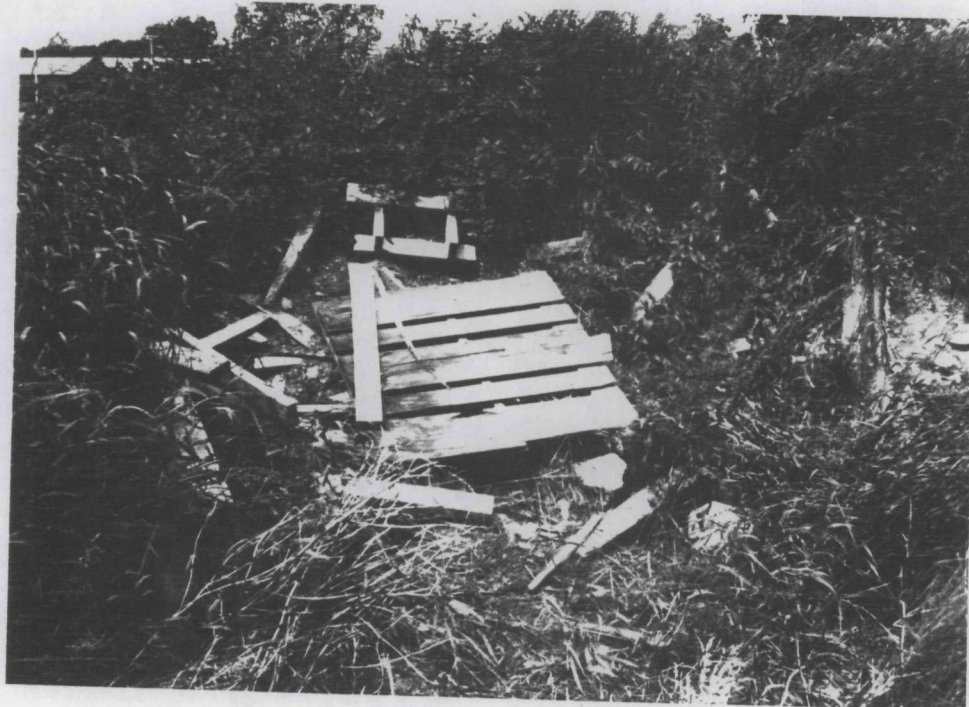
Photograph No. 7 (No. 17 in field notes)

**Observations:** PRC noted vegetation on and around the pile during the VSI. No stains were noted on the soil (see Photograph No. 7).

Groundwater, surface water, air, and on-site soils: Low to moderate. If the soil in SWMU 9, which consists of the top 2 to 6 inches of soil excavated from SWMU 2, is proven to be nonhazardous, it will be assumed that the soil in this unit is also nonhazardous. Therefore, the potential for release would be low. However, if the soil were to contain hazardous constituents, the constituents could easily migrate to all environmental media.

Recommendations: PRC recommends that the facility provide documentation that the soil in SWMU 9 is nonhazardous.

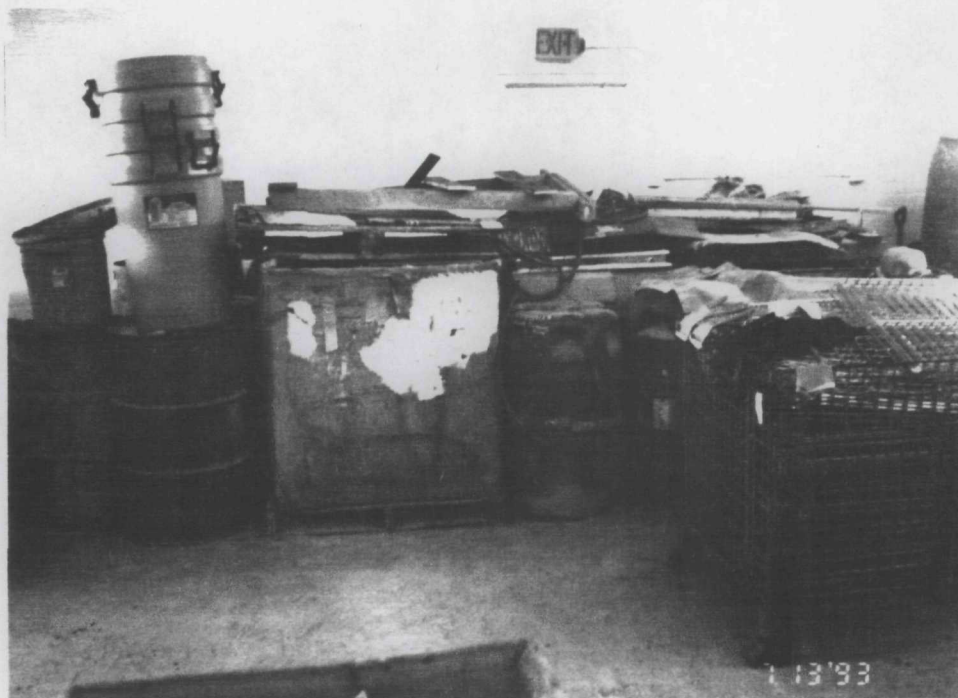
Photograph No. 8 (No. 12 in field notes)

**Observations:** PRC observed no cracks or stains in the concrete at this unit. The boxes were covered with various parts, empty barrels, and miscellaneous items (see Photograph No. 8).

Recommendations: PRC recommends that the facility verify that the soil stored in this unit is nonhazardous and report the findings to IEPA.

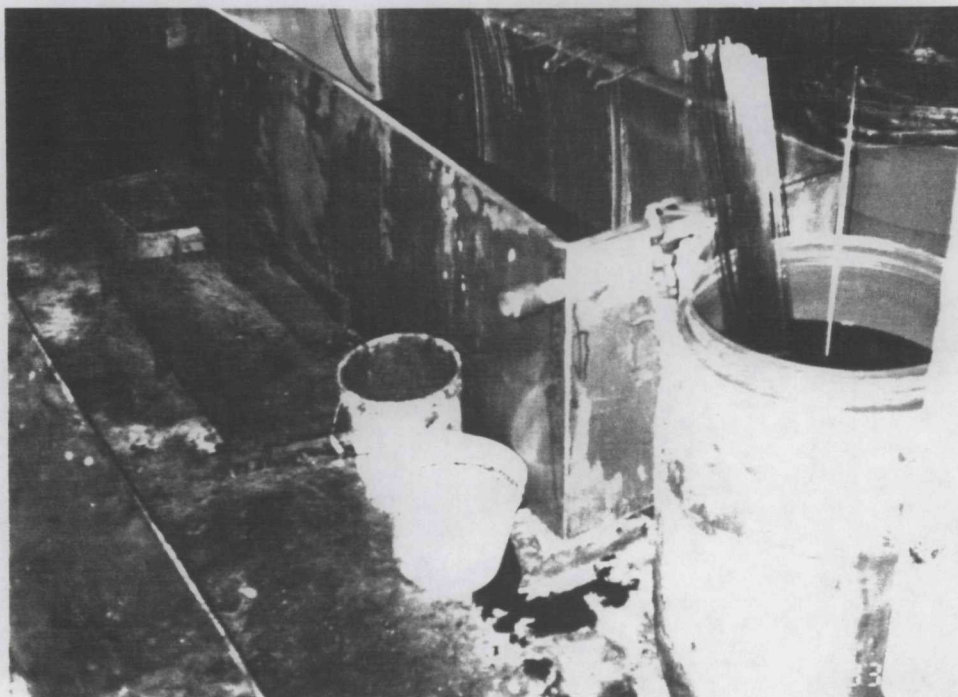
Photograph No. 9 (No. 7 in field notes)

During past inspections, IEPA representatives noted that the five compartments in the Diked Process Area were filled with about 2 inches of dike water (D002 and D007) (IEPA 1986a). At the time of the VSI, PRC observed many areas of pooled dike water. The entire concrete floor of the area could not be observed because a majority of it was covered with either tanks or wooden pallets. The concrete that could be observed was eroded in many places. Also present in the diked area is the standpipe through which RMF discharged spent rinse water to the sanitary sewer system. The standpipe is currently covered with plastic and tape. The overall condition of the diked area was significantly stained and poor (see Photograph No. 9).

Conclusions: This area houses the process equipment and SWMUs 3, 4, 5, and 6. During past inspections, IEPA representatives noted that this area was filled with about 2 inches of dike water (D002 and D007). During the VSI, dike water was pooled in several areas of the unit, and portions of concrete appeared to be eroded. The entire concrete floor in the area could not be observed because a majority of it was covered with either tanks or wooden pallets. Also present in this area is the standpipe through which RMF discharged spent rinse water to the sanitary sewer system. The overall condition of the diked area is significantly stained and poor. The potential for a release to groundwater, surface water, air, and on-site soils is detailed below.

Recommendations: PRC recommends that the facility improve general waste management practices in this area. PRC also recommends that the facility verify the structural integrity of the concrete floor and dike in this area and report the findings to IEPA.

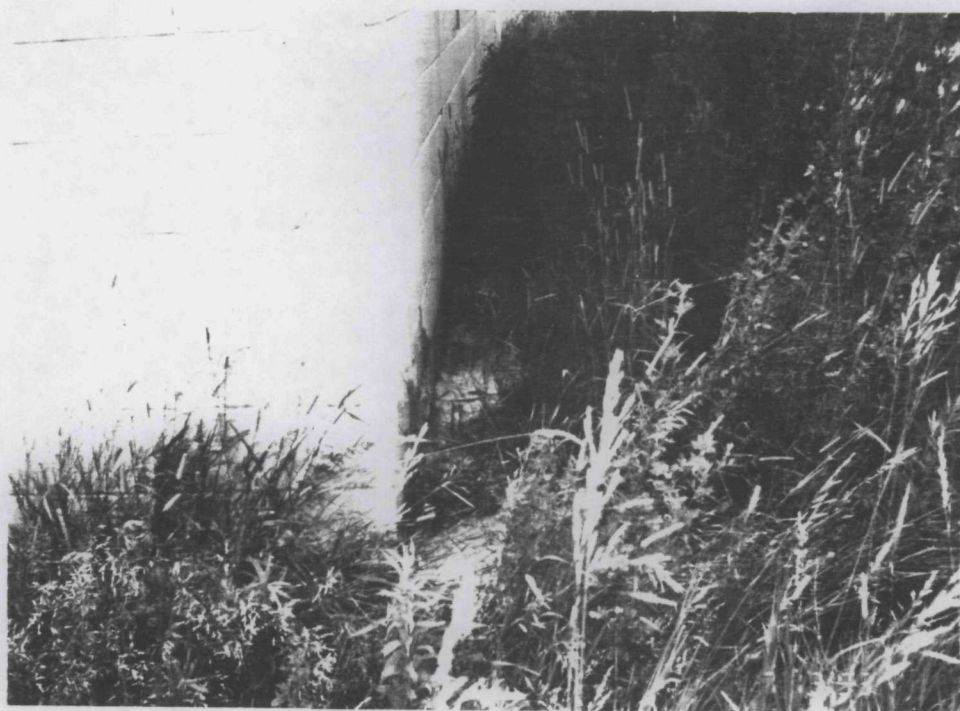
Photograph No. 10 (No. 18 in field notes)

During an April 15, 1992, IEPA CME inspection, a green material resembling electropolishing solution was observed along the exterior wall of the northeast corner of the facility building. The liquid apparently seeped from between the foundation and the exterior wall of the building (IEPA 1992a). According to RMF, the wall was cracked, and spent rinse water from the floor of the Diked Process Area (AOC 1) leaked outside through the crack. On April 29, 1992, an RMF facility representative excavated a 12- by 1.5- by 2-inch volume of soil along the wall. No subsequent sampling activities were performed, so it is unknown if all of the contamination was remediated (see Photograph No. 10).

Conclusions: In April 1992, green liquid was observed seeping from between the foundation and the exterior wall at the northeast corner of the facility building. According to the facility, the wall was cracked, and dike water from the Diked Process Area (AOC 1) leaked outside through the crack. A 12- by 1.5- by 2-inch volume of soil was excavated from this area in late April 1992. The potential for a release to groundwater, surface water, air, and on-site soils is detailed below.

**Recommendations:** PRC recommends that the facility conduct soil sampling at this area to ensure all contamination is removed.
